**Alberta Farm Machinery
Research Centre**

Evaluation Report 598

Spraymaster Model GN 40-60 Field Sprayer

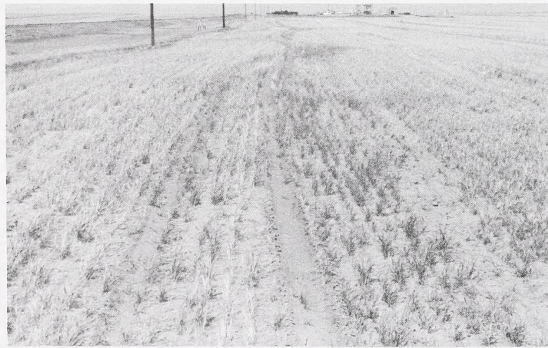
FIGURE 8. Weed Control In and Around Wheel Tracks.

Weed control was good. Weed control was reduced in and around the sprayer trailer wheels due to dust. Weed control was also reduced at the boom spring skid and end.

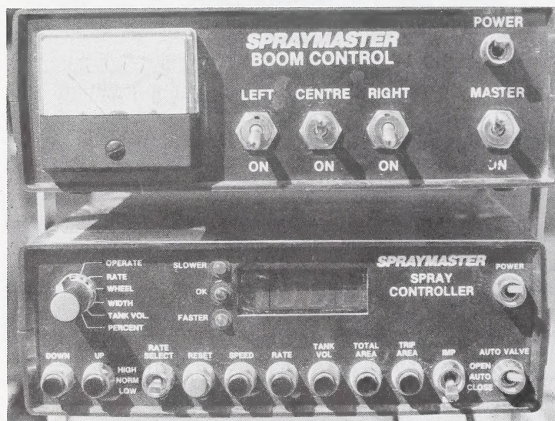
FIGURE 14. Computronics International Remote Control (upper) and Automatic Application Rate Controller Consoles (lower).

The Computronic controller 4-digit LED display screen was easy to read unless it faced direct sunlight. The push buttons, dials and switches were small and difficult to use in rough field conditions.

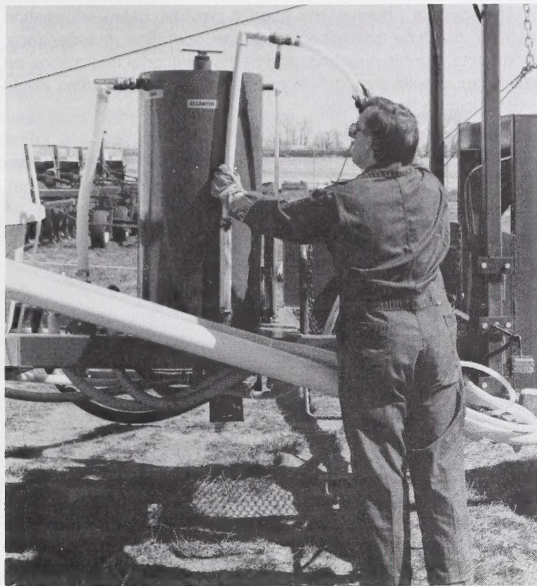
FIGURE 17. Operator Using Chemical Inductor Wand.

The chemical induction wand stored high on the foam marker tank and was difficult to remove and insert. In addition, the bottom portion of the wand was handled when removing or inserting the wand, exposing the operator to the chemical residue (FIGURE 17).

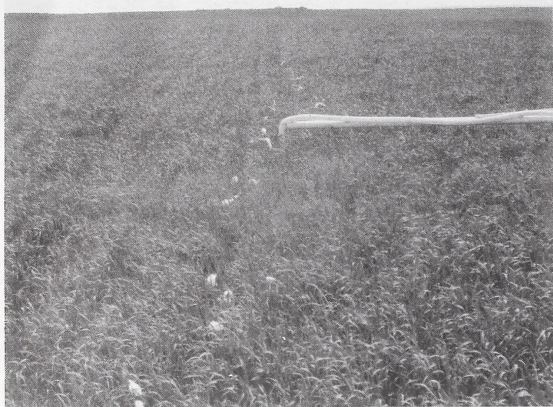
FIGURE 19. Spraymaster Foam Marks.

marks of pink foam (FIGURE 19) that were easy to see and to align with the end of the spray boom. Mark spacing and length could not be controlled or varied. Foam mark spacing and length varied from about 2 to 10 ft (0.6 to 3.0 m) and 3 to 10 in (76 to 254 mm) respectively.
